# Service Bulletin

**Subject:** P16D0 Oil Leak Inspect Oil Galley Plugs In Head

**Models:** 2014-2015 Chevrolet Impala  
2014-2015 Chevrolet Malibu  
Equipped with 2.5L RPO LKW

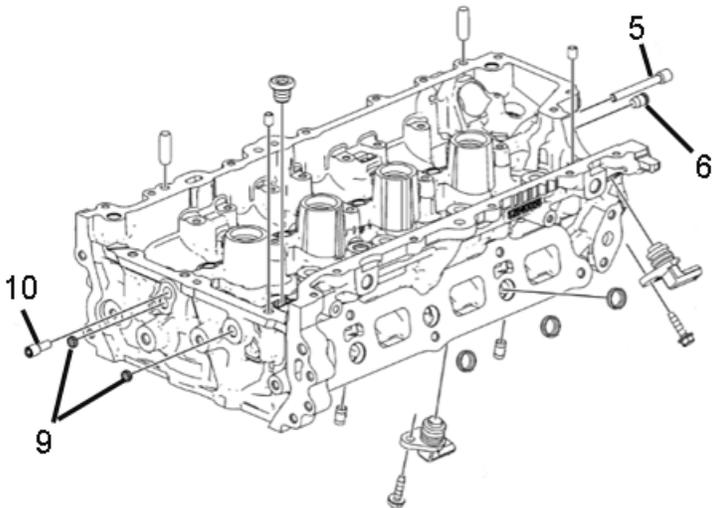
After cylinder head replacement, the head may have an external oil leak and/or set P16D0

If code P16D0 sets, verify oil galley plug #10 (see illustration below) has been installed. This oil galley plug is located in the head, behind the timing cover and would have an engine oil leak that is internal of the engine.

If the head has an external oil leak, verify oil galley plugs #5 and #6 (see illustration below) have been installed.

Oil galley plugs #9 (see illustration below) should already come installed in the new head.
